Lancia Beta Seat Runner Overhaul.

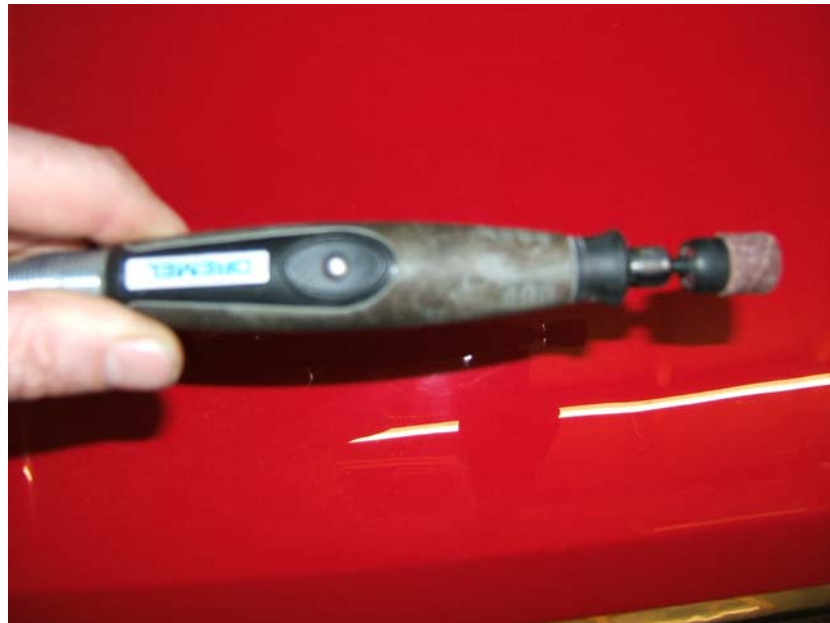
The Dremel "bit"

Dremel with suitable fitting (see pic.) or a soft backed disc on a small angle grinder.

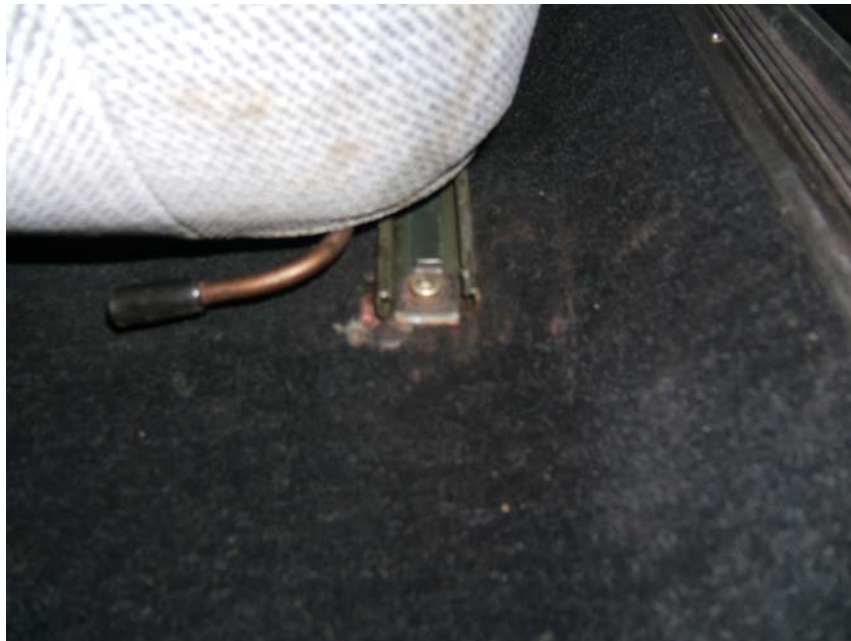
With all four bolts removed the seat should now lift out.

Check that all four large packing washers are present. Each one should be sandwiched between the raised chassis mounting points, above the captive nuts and the bottom of the seat runners. You need these, so they must be present! Otherwise your seats will not operate correctly and catch on the carpet.

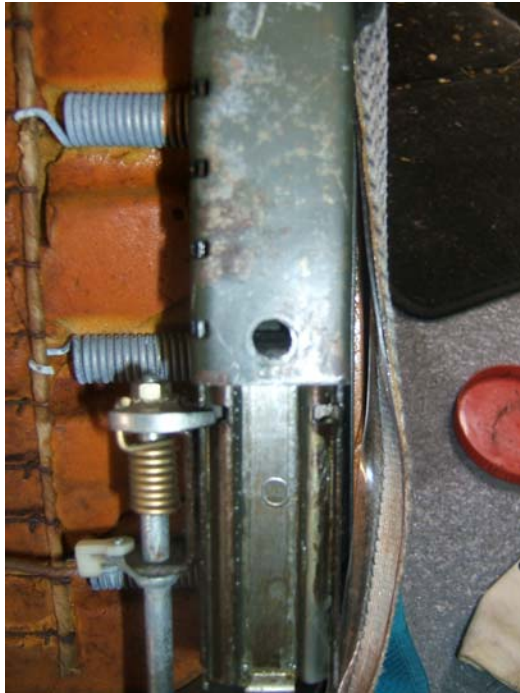
Front

You can see approximately $\frac{3}{4}$ of the black rollers through the holes. Note the locking notches - these should always face inwards towards the centre of the front seat.

Operate the seat locking handle to allow the seat runners to move (unlocked), slide one of the runners all the way forward, once the runner has travelled as far as it can you should be able to see the roller through the small hole in the lower runner. When you see the roller you need to put the small screwdriver behind it and lever / pop it out.

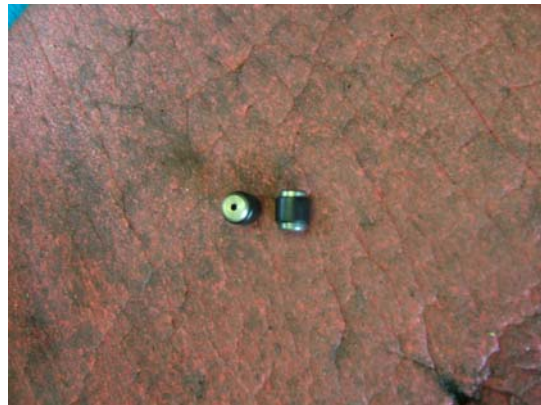
Once they are out keep these two rollers safe!

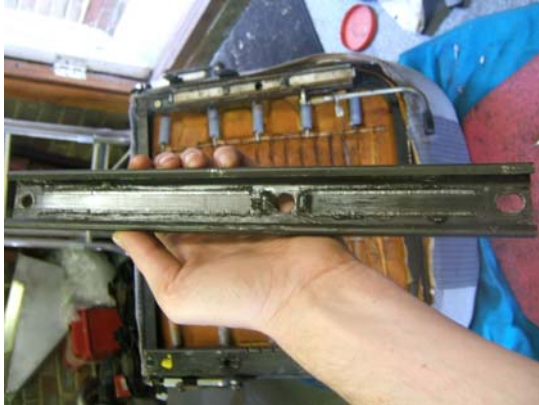
The channel where the rollers operate should be free of grease, the grease will cause the rollers to slip rather than roll and also the rubber will swell making it increasingly more difficult to move the seat.

Lower runner covered in grease.

Once the runner is free, clean both the upper runner that is still attached to the seat and the lower runner that is now unattached. I used engine degreasant and plenty of rags / tissues, then finally blow clean with the airline.

These runners should be 100% grease & dirt free

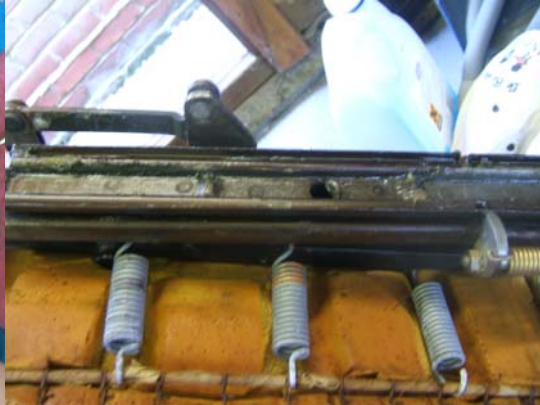
Upper runner also covered in grease

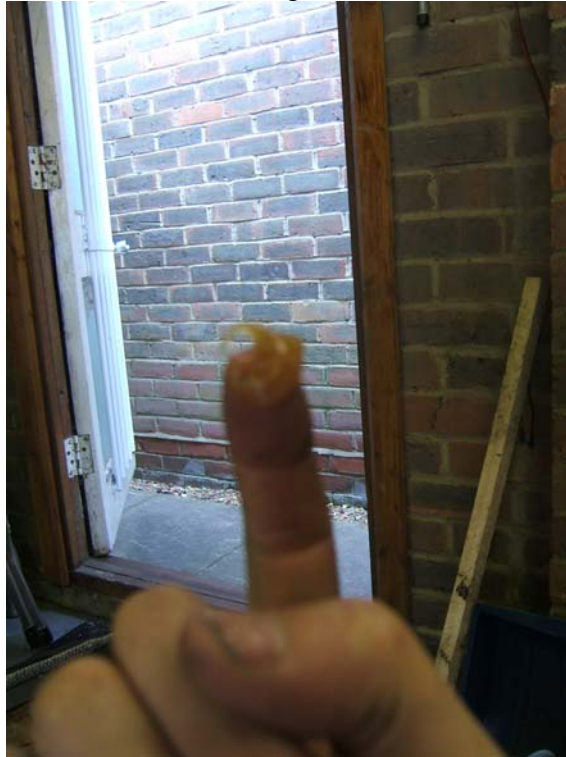
This much grease!

Once you are happy that the runners slide freely up and down then you're ready to reassemble this side of the seat. Put a small amount of grease on the outer edge of the upper runner (the section that you have just dressed if you needed to).

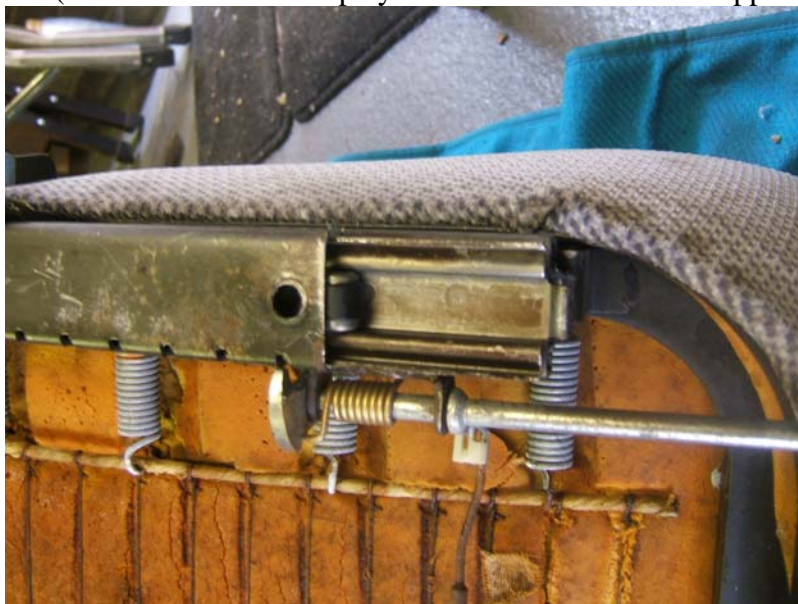
Unlock the seat again and slide the runner all the way back until the lock reaches the first notch (See pic.). Again push the roller back into place between the upper and lower runners. (You should feel the “play” between the runners disappear).

Slide the lower runner from the rear onto the upper runner all the way to the last notch so that the seat is now locked in position. Place one of the rollers at the back and push it back into place.
